HISTORIC TIMBER REPAIR TECHNIQUES TYPOLOGY IN HERITAGE BUILDING CONSERVATION; AN ANALYSIS OF MALAYSIAN PRACTICE

Abstract: Timber has been an integral part of Malaysia's architectural heritage, contributing to the uniqueness and historical significance of its heritage buildings. As the conservation of heritage structures gains importance, the practice of repairing historic timber elements becomes paramount. This study objectives are (i) to explores the methods, challenges, and significance of historic timber repairs in Malaysian heritage building conservation (ii) to investigates the practice of historic timber repairs in heritage building conservation in Malaysia and (iii) to examine the methods, materials, and approaches employed in historic timber repairs in Peninsular Malaysia. The use of timber in traditional Malaysian architecture has made a significant contribution to the country's architectural heritage. However, the diminishing supply of historic timber resources and traditional knowledge in timber restoration pose increasing challenges to the preservation of this heritage. The research also analyzes the challenges and issues faced by conservation professionals and contrac

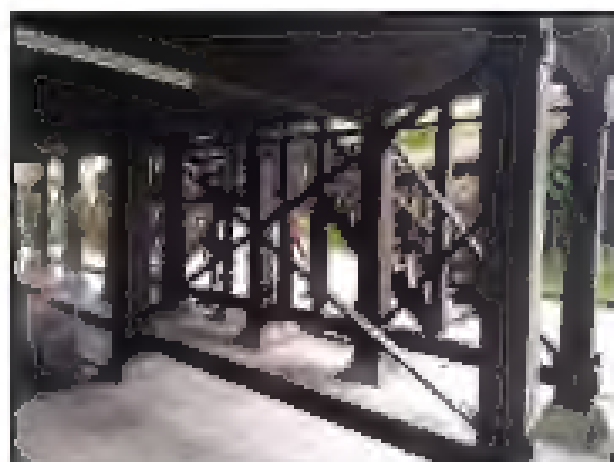
Figure 1: The additional structure consolidation by steel braces on the columns of Istana Satu was once relocated to the Malaysia National Museum compound (Author, 2019).

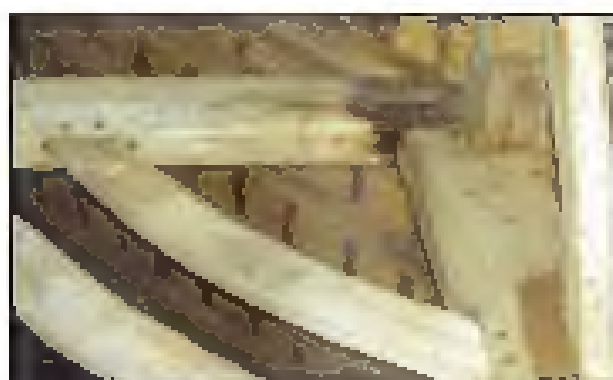
Figure 6: The Epoxy resin repair to the end of a beam consolidated and replaced the missing part (English Heritage, 2012).

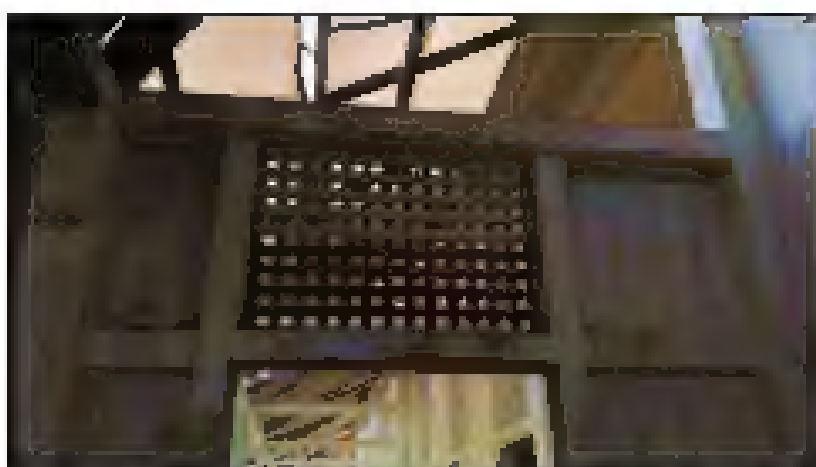
Figure 8: Some of the replaced timber lattice members, which remain unfinished, were replicated based on the original ones that are still intact (Author, 2017).

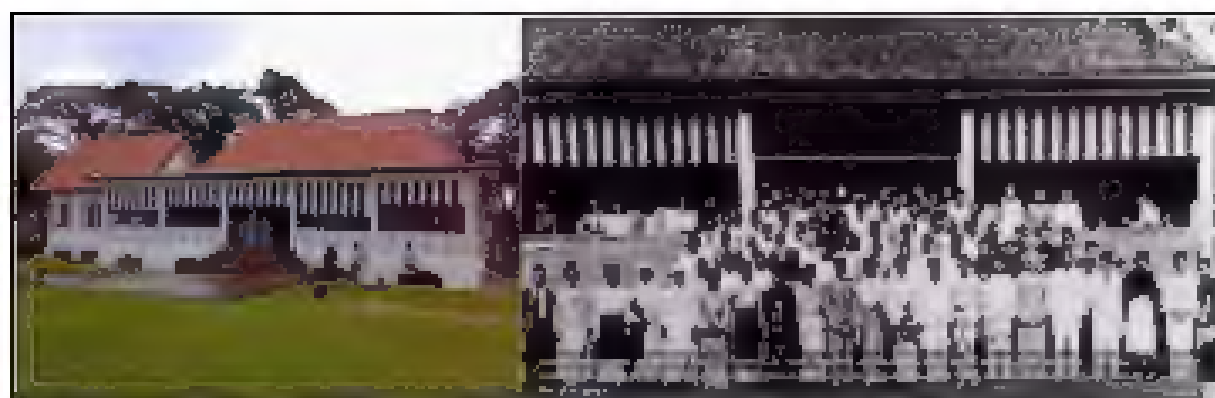
Figure 9: One of the timber blocks of the Sultan Suleiman Club, rebuilt in 2007, referred to an old photograph from 1947 to estimate the scale of the building (Jafri Mexican Architect, 2007).

Aside from replication work on building parts, the complete or partial rebuilding of a destroyed building is also considered a last-resort option to preserve historical and cultural evidence. Rebuilding should, as much as possible, replicate the original appearance of the building based on remaining information such as photographs, old blueprints, and oral accounts from senior citizens. Timber buildings are constantly exposed to the risk of fire and tend to deteriorate more quickly than masonry buildings. Based on experiences in Malaysia, the Sultan Suleiman Club Building in Kuala Lumpur is one example of a timber structure that was partially rebuilt in 2007. The Sultan Suleiman Club, established in 1909 in Kampung Baru, Kuala Lumpur, holds historical importance as the oldest and most prominent club specifically founded for the Malay community (Jafri Mexican Architect, 2007).

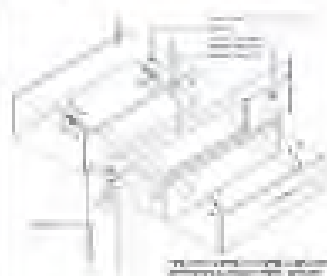
<p>Custom steel plates were clamped and fastened with nail on both sides of the cracked beam for reinforcement. This technique avoids replacing the beam, which could cause more severe structural damage.</p>

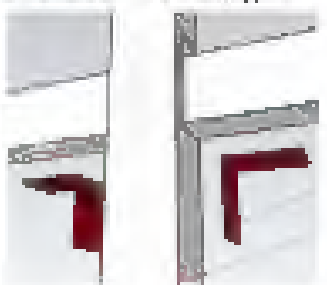
<p>Steel L-brackets (red) are attached with screws to transfer the building load from the beam to the column, bypassing the mortise-tenon joint, which is suspected to be weakened. The purpose is to avoid damaging the joints.</p>
				<p>Additional rectangular steel section</p>
